EXTERNAL PITTING AND CREVICE CORROSION OF 316L STAINLESS STEEL INSTRUMENT TUBING IN MARINE ENVIRONMENTS AND PROPOSED SOLUTION

Akinyemi Okeremi

Shell International Exploration and Production
200 North Dairy Ashford
Houston, TX 77079 USA

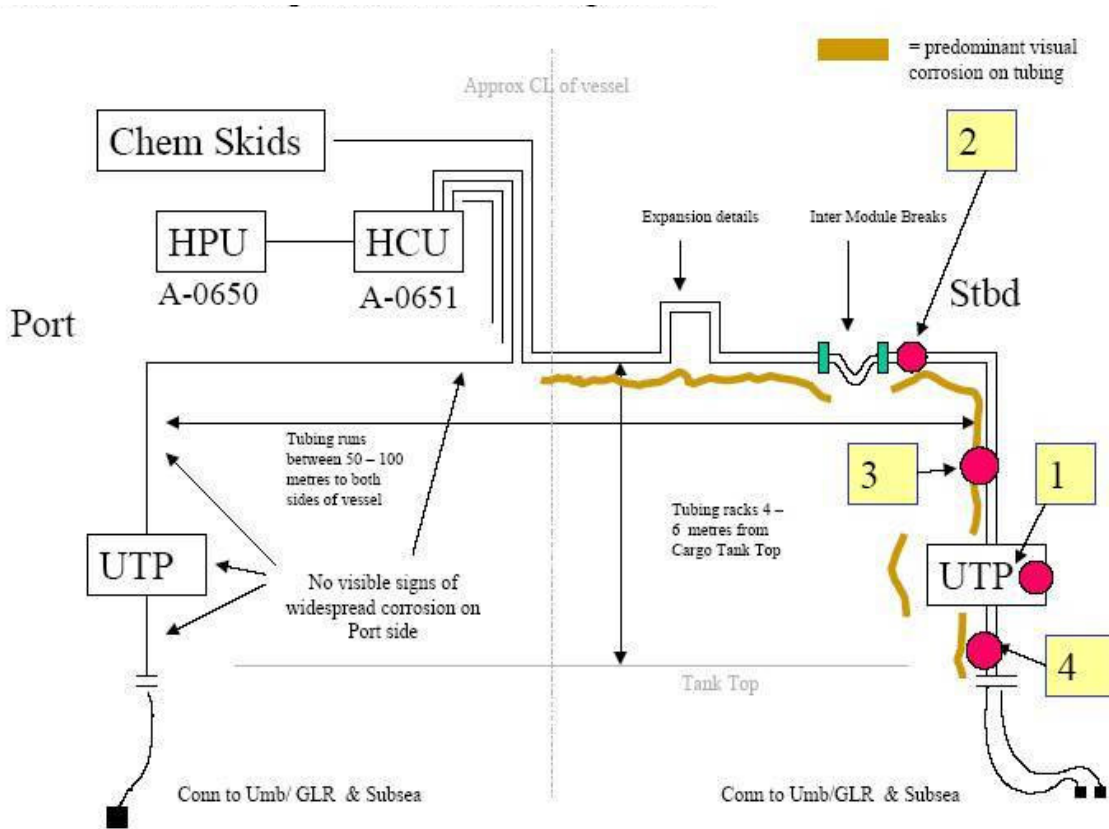
The first failure was topside stainless steel tubing associated with the Subsea Umbilical system, i.e. tubing between the Umbilical Termination Panels (UTP) and the so-called Medusa heads. Figure 1 shows the schematics of the tubing indicating four different failure locations. All the tubes were made of longitudinally welded AISI 316L with compression type connector except for the umbilical tubes that go Subsea that were made of Super Duplex Stainless Steel (SDSS) and are not addressed in this paper. The tubing contained hydraulic fluid and the four failures occurred within 6 months intervals, with the first failure just barely five months after the FPSO was moored in place.

Figure 1: Subsea system tubing between the Umbilical Termination Panels (UTP) and the Medusa heads

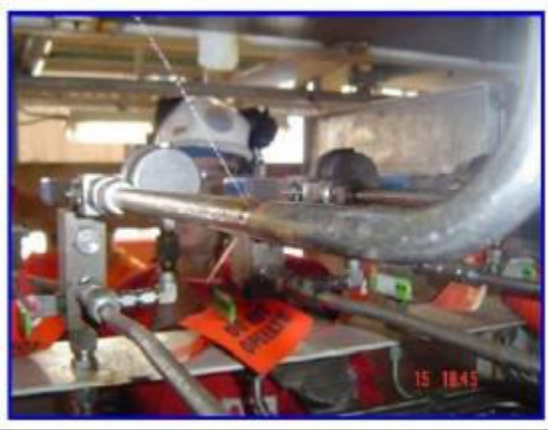
The first incident was a pinhole leak during a pressure test within the UTP. The failed tube was analysed and the material confirmed to be AISI 316L with Molybdenum content of 2.08%. Figure 2 shows the pinhole leak while Figure 3 is the cross section of the tube showing the pit morphology, which is typical for stainless steel pitting such as caused by chlorides. Although there were many signs of general external corrosion, it was thought that most of these tubes were superficially attacked and the deeper attack that led to a failure was an isolated event caused by chloride pitting.

Figure 2 Pressure test leak within UTP

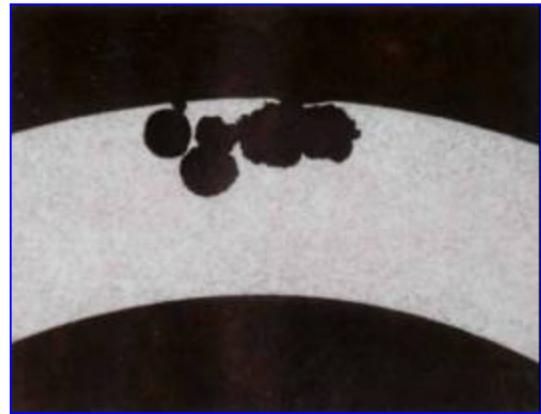
Figure 3: Cross-section of tube with pit

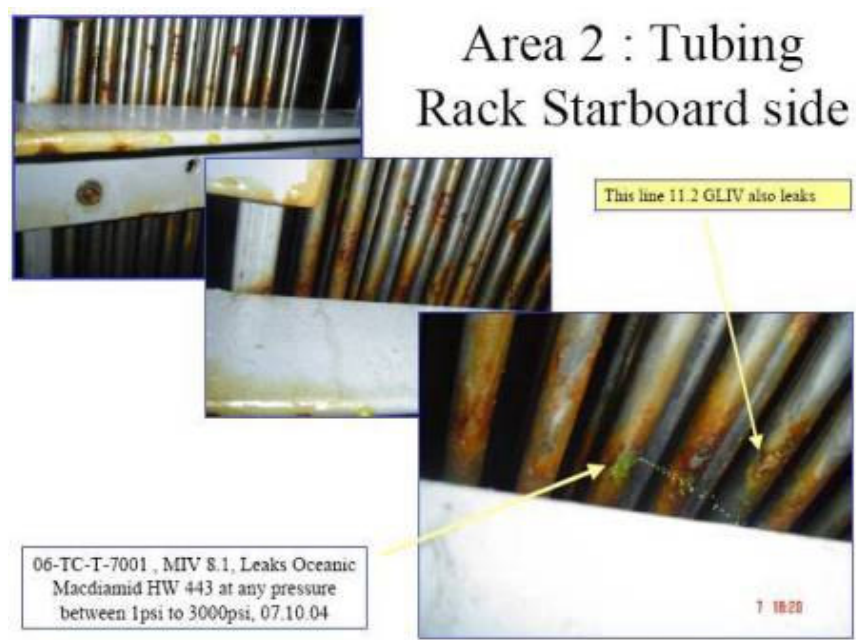
Within a very short time, corrosion propagated quite rapidly, it was however interesting to note that there were significant differences in the degree of attack between various locations. Corrosion was rampant on the starboard side of the vessel and much less on the port side. Figure 4 shows a tubing rack on the starboard side and location of failure site 3 identified in Figure 1. As a result of the mooring orientation, the starboard side is directed toward the prevailing wind, hence is more likely to be exposed to salt spray. The humidity is extremely high in the Gulf of Guinea hence most of the vessels and equipment are continuously moist, in addition heavy rain showers are common in the region. Although rain adds to the wetting of some surfaces, it also washes off some of the salt deposits. Apparently the net effect is favourable on the port side and not on the starboard side.

Figure 4: Tubing Rack on the Starboard side

The corrective action taken was to replace all the AISI 316L tubing on the starboard side immediately with an alternative material and a recommendation to replace those on the port side within twelve months considering the degree of crevice corrosion at the clamps.

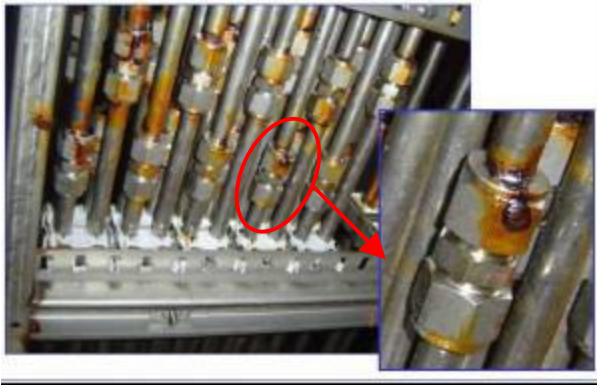
It should be noted that the tubing shown in Figure 5 and Figure 6 are not directly exposed to rain water because they are located underneath a solid deck. In this case, corrosion is more prominent at the tube and union connector interface and also at the bends. A repeat failure analysis on other leak sites concluded that the failure mechanism was the same as the initial failure. Again the Mo content was minimal (2.05%). The failure analysis concluded that the failure mechanism was pitting and crevice corrosion. No crack was observed in any of the failures. This is consistent with the collective experience of other oil companies interacted with. The only stress corrosion

Figure 5: Corrosion of tubing and couplings

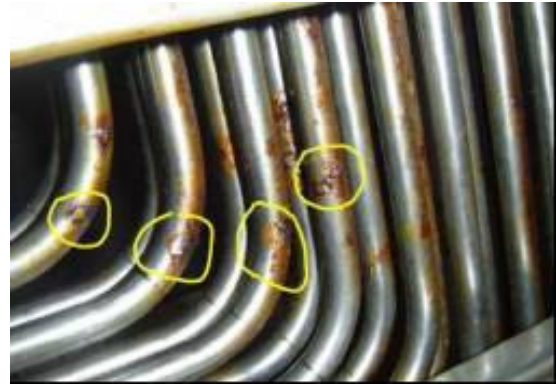
Figure 6: Deep pits on bends
