ALTERNATIVE PRODUCTS: LOW INITIAL COST DOES NOT REFLECT THE TRUE COST OF OWNERSHIP

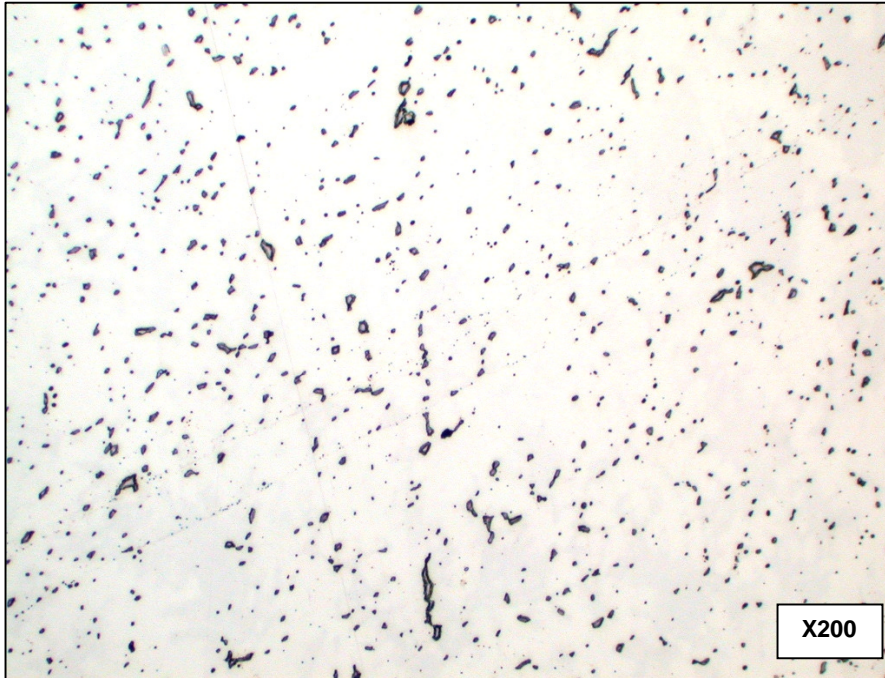
Figures 1, 2 and 3 show the cross section of a forging from a lower cost competitor, now gaining popularity in our market. Although what is shown is indeed an austenitic stainless steel (i.e. austenite grains were observable), what the micrographs have also revealed is a high density of inclusions and impurities, before and after chemical etching. Those alloying additions (dark areas) are believed to be ferrite- δ ¹, manganese sulphides² and possibly carbides³ which have detrimental effects on mechanical properties and corrosion resistance, as it will be shown later in this study.

Figure 1 – Polished sample before etching. High density of inclusions and alloying additions are observable.

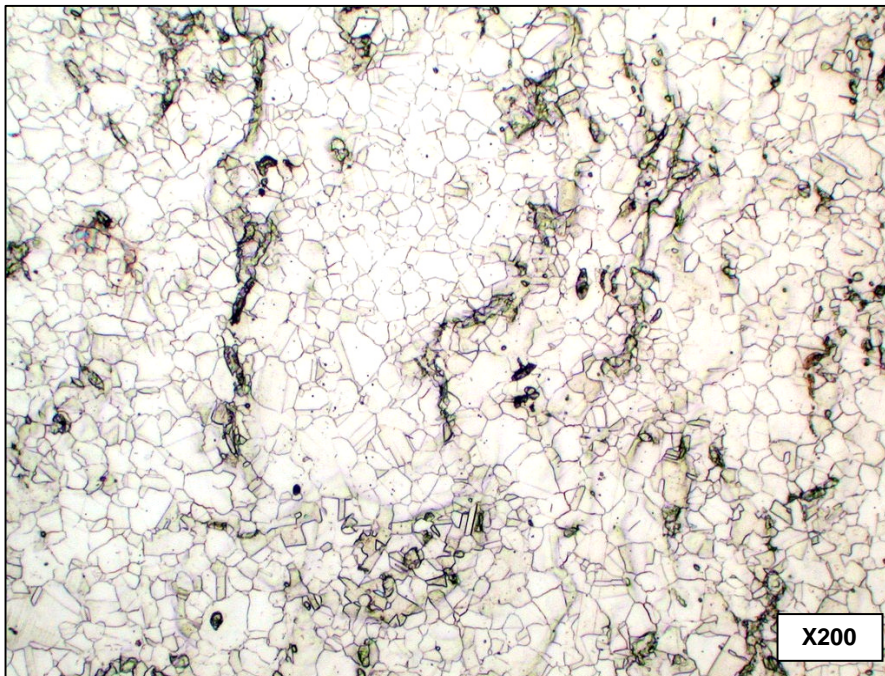
Figure 2 – Polished and electrolytically etched sample (10% aqueous oxalic acid, 2.5V dc, 45 s). Microstructure of a forged part, showing austenite grains and high density of inclusions.

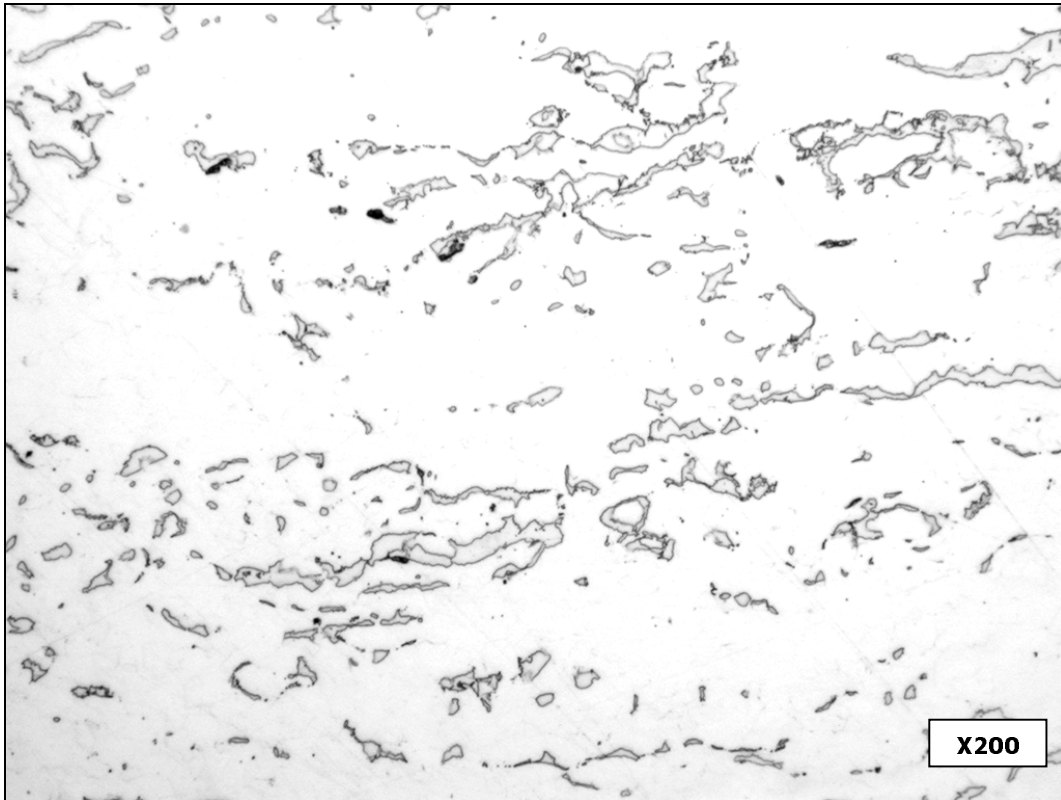
¹ This alloy would seem to be an austenitic type of material which contains tiny patches of residual delta ferrite (formed during cooling), and therefore is not a true austenitic in the strict sense of the word. The delta ferrite can lead to sigma embrittlement.

Figure 3 - Ferrite delta stringers were characterized on a forged part. The sample was polished and etched with Kalling's No.2 Reagent.

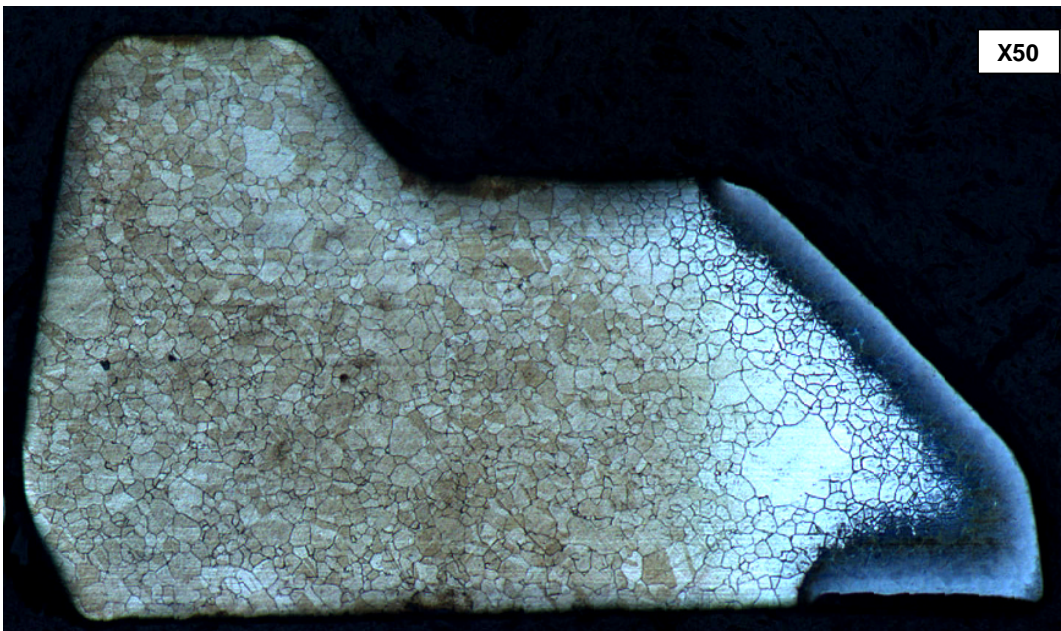
The back ferrule hardening treatment was identified as Edge-Hardening, which is normally associated with poor corrosion resistance properties. Figure 4 shows the details of the edge-hardening treatment. The treatment is believed not only to reduce the corrosion resistance but also to modify the microstructure of the ferrule (probably due to high temperatures associated with the process and high inclusion density of the base material).

Figure 4 – Back Ferrule: Edge-Hardening Detail. Microstructure revealed by etching the sample with Kalling's No. 2 and Aqua Regia Reagents.

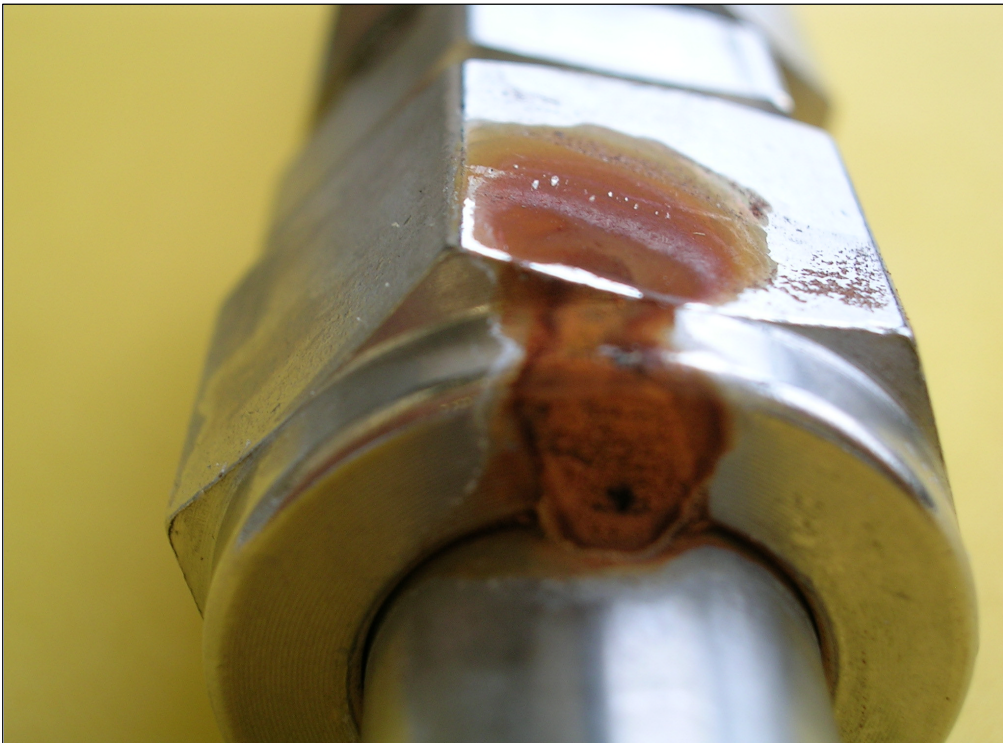
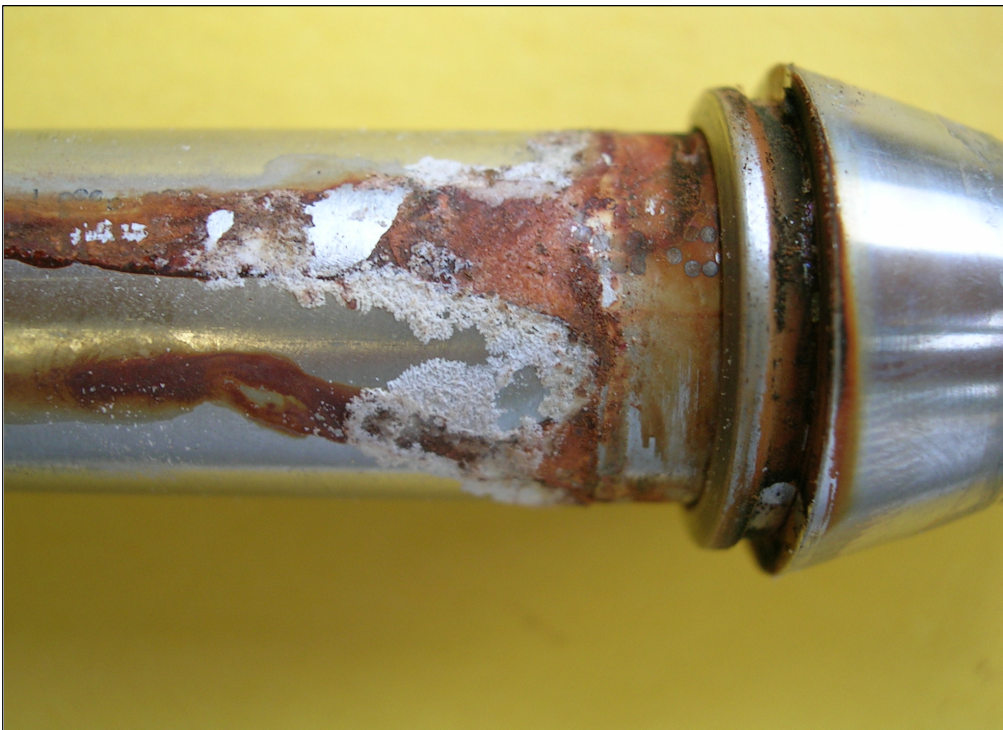
Other examples of these tube fittings were subjected to a 175 hours Salt Spray Test as per ASTM B117. Typically, no signs of corrosion are expected to be seen before 100 hours. However, these lower cost products showed corroded areas after only 24 hours of salt spray exposure.

The corrosion is believed to be initiated on the vicinity of the nut-ferrules/tube interface as depicted in Figures 5 and 6. The corrosion resistance of those specimens is a serious threat for the integrity and reliability of the fittings' performance. This severe localised corrosion will eventually lead to damage and ultimately premature and possibly fatal failure, often without previous warning in the short to medium term (depending on media contained and operating environment).

Figures 5 and 6 – Tube Fitting Assemblies with Stainless Steel 316 Tubing after 175h Exposure to Salt-Spray Test as per ASTM B117 Specification.

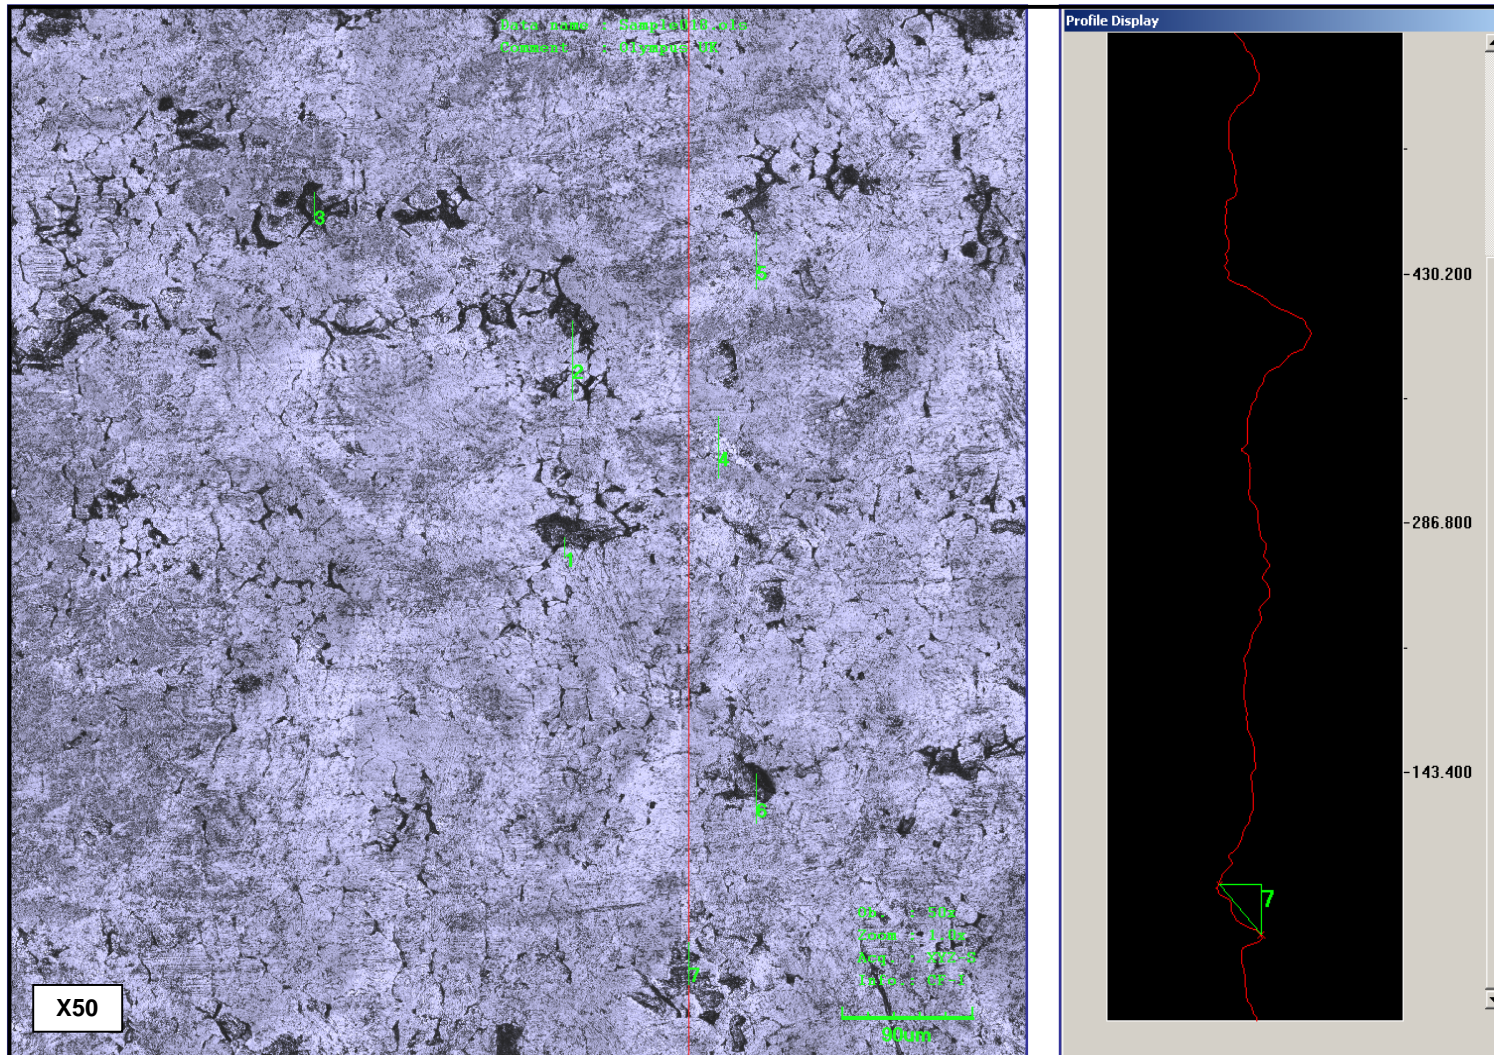
underneath salt and rust deposits were the selected spots for the corrosion study. Figures 7, 8 and 9 were taken by the confocal laser microscope and showed that two types of localised corrosion are taking place: crevice corrosion and intergranular corrosion. This is despite the fact that many of these products will be sold specifically as being resistant to these corrosion mechanisms.

Figure 7 – Confocal Laser Macrograph : Area Under Rust Deposits. Localised Corrosion is taking place (see presence of pits and intergranular attack).

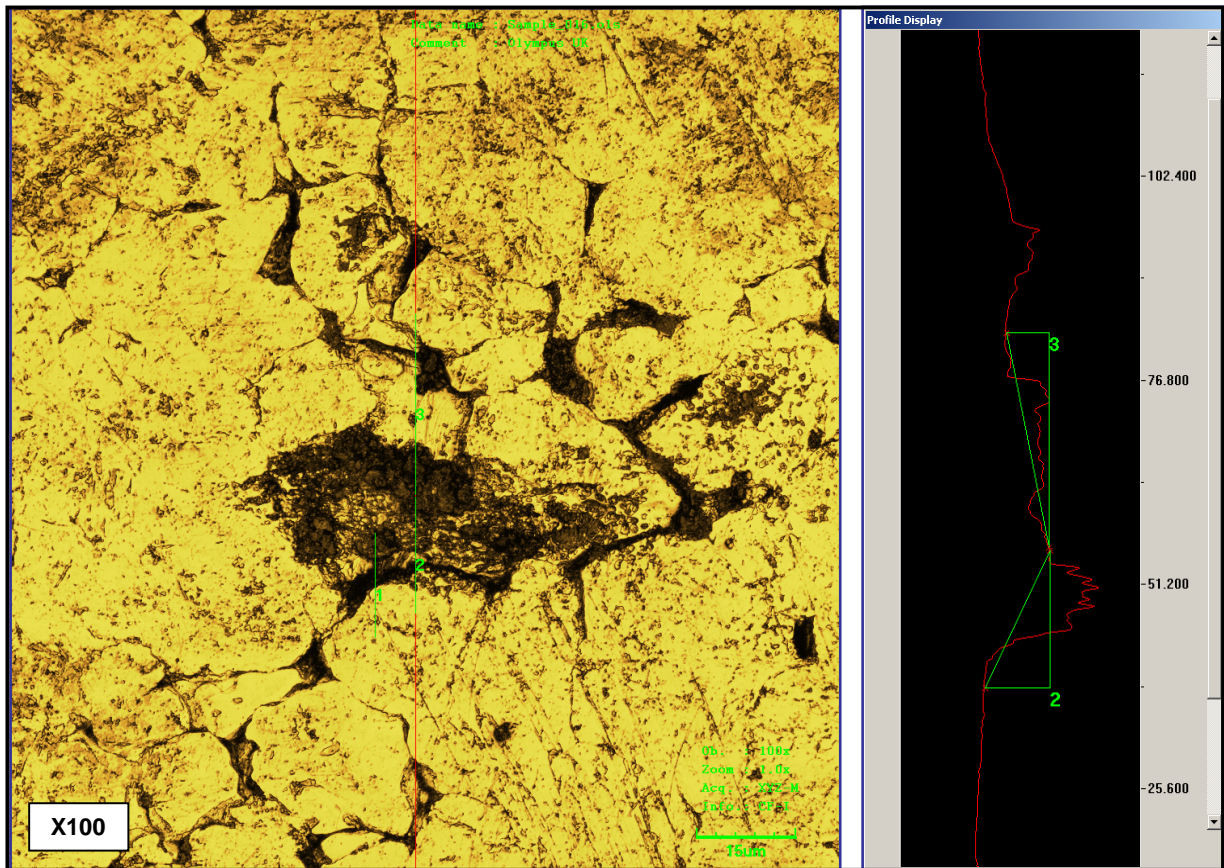
Figure 8 – Confocal Laser Micrograph : Details of Pitting & Intergranular Corrosion.

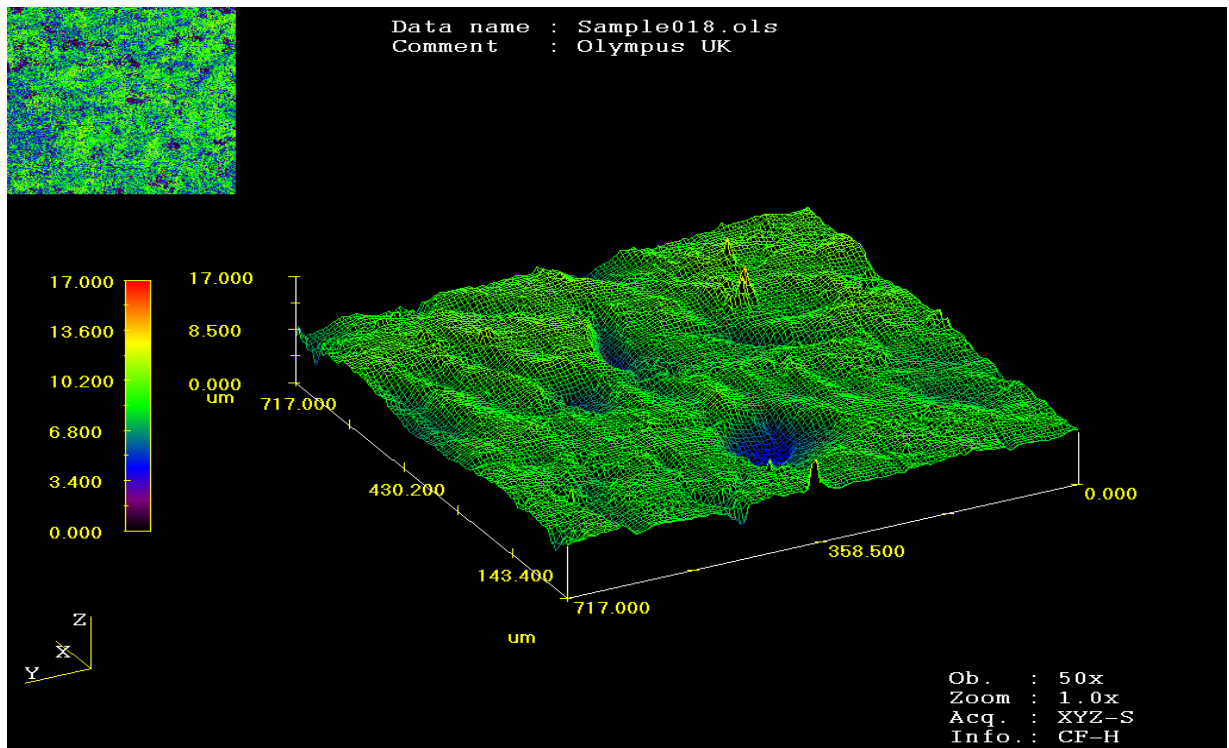
Figure 9 – Confocal Laser Micrograph; 3D Roughness Profile; Pits' Depth;

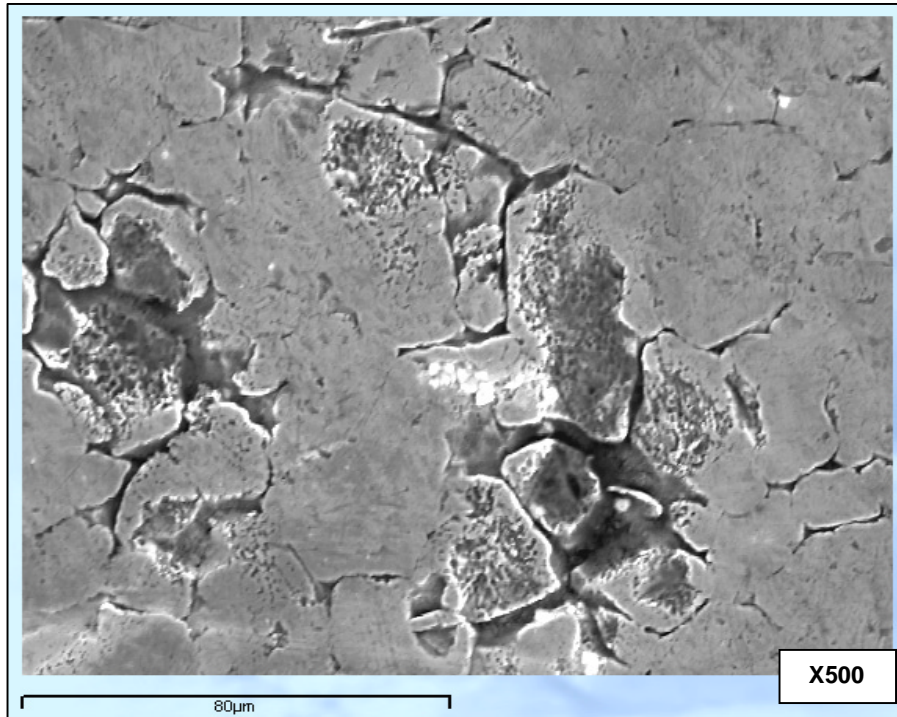
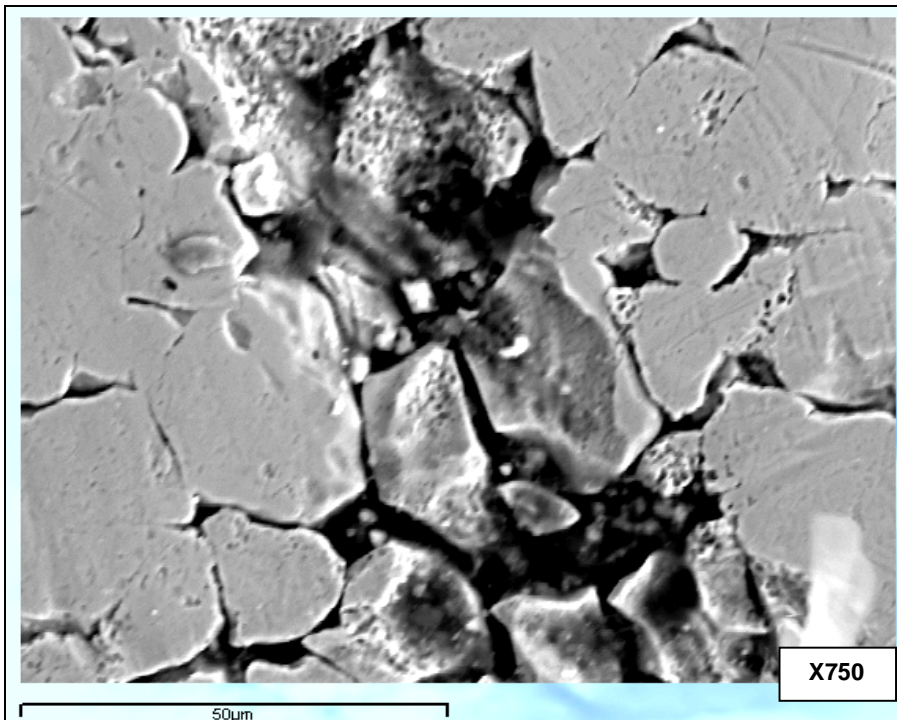
SEM micrographs (Figures 10 and 11) show details of the crevice and intergranular corrosion taking place only after 175 hours of salt-spray exposure.

Figures 10 and 11 – SEM Micrographs. Detail of Localised Corrosion taking place on the material's surface.
