EXTERNAL PITTING AND CREVICE CORROSION OF 316L STAINLESS STEEL INSTRUMENT TUBING IN MARINE ENVIRONMENTS AND PROPOSED SOLUTION

Akinyemi Okeremi

Shell International Exploration and Production
200 North Dairy Ashford
Houston, TX 77079 USA

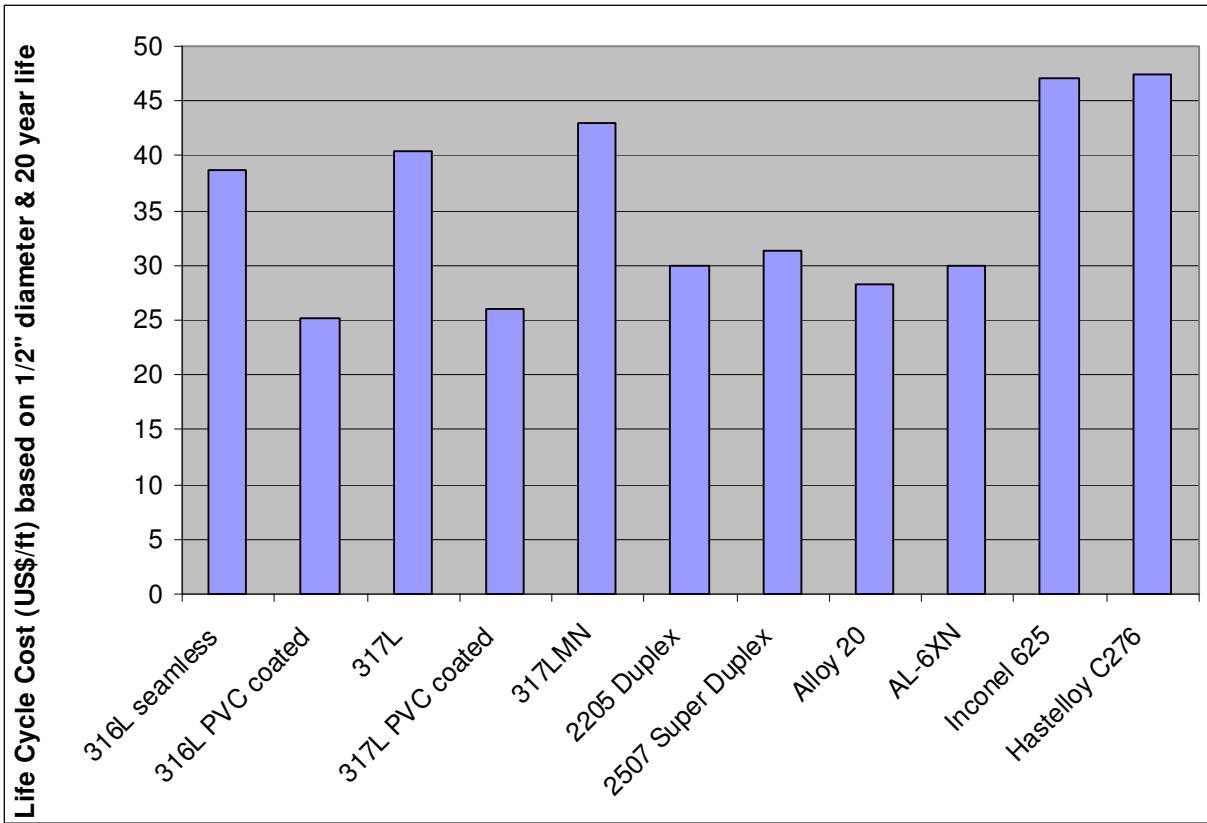
Figure 7: Lifetime Capital Cost Comparison for Instrument Tubing

Figure 7 gives a comparison of life cycle cost (prices for initial installation and future rework) in USD/ft based on 20-year life of 1/2" diameter instrument tubing taking into account high strength and wall thickness reduction for pressure calculations.

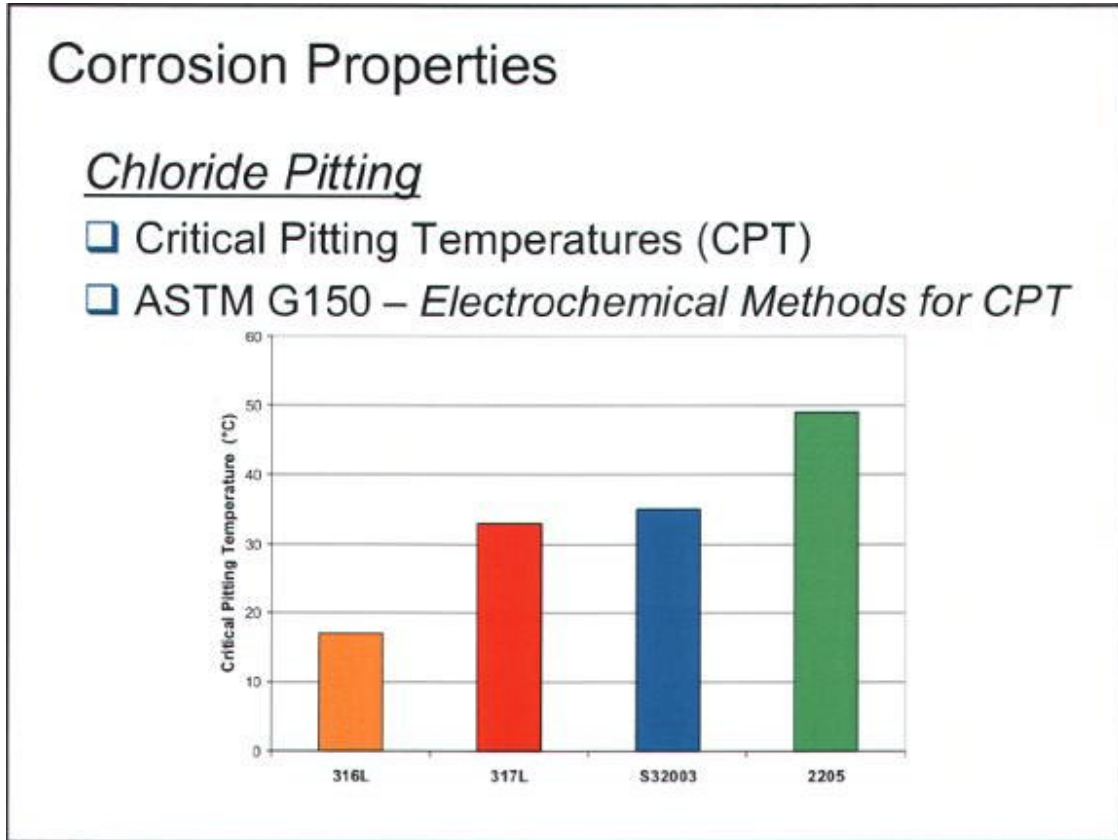
Figure 8: Critical Pitting Temperature¹

3. Figure 8 gives the Critical Chloride Pitting Temperature of some common alloys measured using ASTM G 150

The electrochemical method yields a CPT of 48°C for Alloy 2205 as compared to 16°C for AISI316L while Figure 9 gives the Critical Chloride Crevice Corrosion temperature of Alloy 2205 using ASTM G48B in a ferric chloride solution for 72 hours as 20°C compared to -2°C for AISI316L.

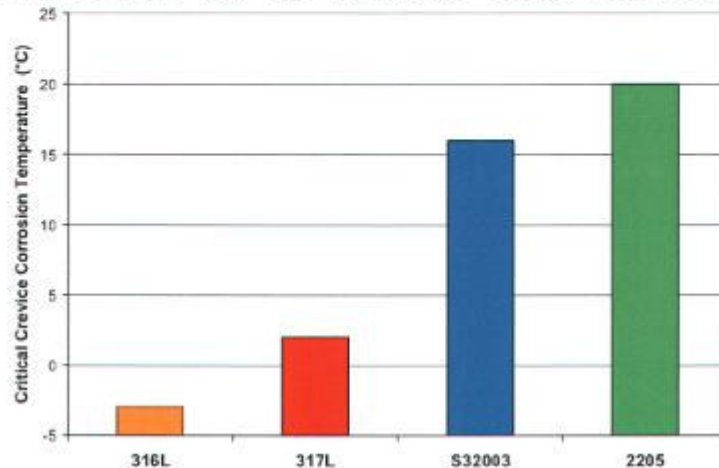
Figure 9: Critical Crevice Temperature²

Although 22Cr duplex stainless steels seem to exhibit better resistance to pitting and crevice corrosion than AISI 316L nevertheless, they are known not to be suitable for aerated seawater service due to their extreme susceptibility to crevice corrosion. This material is not considered suitable for this application especially in the tropics where the temperature is usually above the critical crevice temperature almost all year round.
